STUDY ON THE ECONOMIC EFFICIENCY OF SLOPE CONSOLIDATION BY DIFFERENT METHODS

Abstract

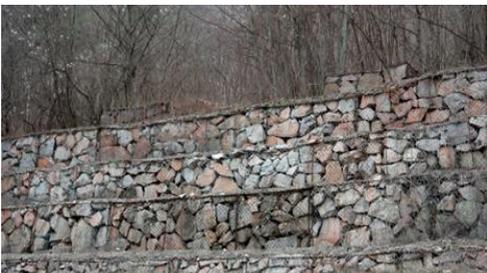
Figure 1. Gabions

To consolidate the degraded slopes with vegetation we used the following species *Hedera helix*, *Campsis radicans*, *Cotoneaster horizontalis*, *Euonymus fortunei* and *Chaenomeles japonica*. 150 plants were used, 30 pieces of each species. The expenses for a plant varies between 19 and 35 RON. The planting of the species was done manually in pits of 15 x 15 x 20 cm and 30 x 30 x 35 cm. In order to carry out this work, two workers were needed, who dug, planted and watered the plants. The plants were planted with the root ball in ground. To consolidate the degraded slopes with gabions (Figure 1), in order to carry out this work, an excavator was needed to dig the foundation where the gabions will be located. The following materials were used: galvanized wire mesh with 2 mm wire diameter and 40 x 40 mm eye dimensions - 891 m²; steel bar with 16 mm diameter - 1188 m; galvanized wire with 2 mm wire diameter - 600 m, broken stone with 44 mm diameter - 223.08 m³. In order to carry out this work, three workers were needed, who worked 120 hours to complete the task.

In Table 2 was calculated the economic efficiency for the consolidation of the degraded slope using gabions. Expenses for excavation are 1700 RON.

The material needed for the arrangement slope cost 20159.75 RON and labor cost 3760 RON. So the cost of arranging a slope area of one m² is 256.19 RON.

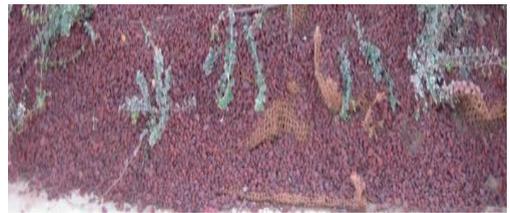
To consolidate the degraded slopes with neds biodegradable jute, expanded clay and vegetation (Figure 2), was needed nets biodegradable jute having the technical data: 290 g/ml 101 cm x 1 ml. 110 m² of biodegradable jute were needed, 100 liters of expanded clay and 100 pieces of stakes to support the nets biodegradable jute on the ground.

Figure 2. Neds biodegradable jute, expanded clay and vegetation

Also, the folowing ten species of ornamental shrubs both through the leaves and flowers were used: *Juniperus horizontalis*, *Forsytia suspensa*, *Lonicera pileata*, *Syringa vulgaris*, *Viburnum opulus*, *Buxus sempervirum*, *Weigela florida*, *Kerria japonica*, *Cedru feeling Blue*, *Betula pendula*. In order to carry out this work, two workers were needed, who worked 36 hours to complete this work.

The plants were planted with the root ball in ground. The planting of the species was done manually in pits of 15 x 15 x 20 cm and 30 x 30 x 35 cm.

In Table 3 was calculated the economic efficiency for the consolidation of the degraded slope using nets biodegradable jute, expanded clay and ten species of ornamental shrubs both through the leaves and flowers. Total expenses for the consolidation of 100 m² of slope were:

the net biodegradable jute cost 1309 RON, the expanded clay cost 163 RON, vegetation cost 1684.12 RON and the pieces of stakes to support the net cost 250 RON, and the labor was 1329 RON.

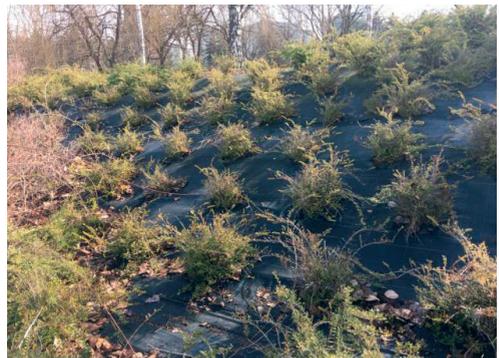
To consolidate the degraded slopes with geotextile (Figure 3), were used 110 m² of geotextile and 150 pieces of stakes to support the geotextile on the ground. A worker worked 12 hours to complete this work.

Figure 3. Geotextile

In Table 4 was calculated the economic efficiency for the consolidation of the degraded slope using geotextiles. The necessary for the material amounted to 1154.9 RON, as follows 7799 RON cost 100 m² of geotextile, 375 RON

cost 150 pieces of stakes to support the geotextiles and the labor was 950 RON. So the total cost of consolidation of 100 m² of slope was 2104.9 RON and the cost for 1 m² of consolidation with this material is 21.04 RON.
