## EVOLUTION OF LAND USE CATEGORIES AND THE EROSION DEGRADATION STATE OF THE AGRICULTURAL LANDS IN THE SUCEAVA COUNTY

**Simona-Gabriela CIOCAN, Simina-Mirela RĂILEANU, Daniel BUCUR**

### **Abstract**

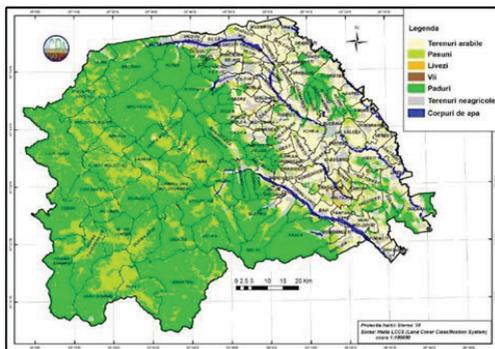
Figure 1. The map of land use categories distribution in Suceava County

Agricultural land has a significant distribution in the plateau unit, the arable surface is found in the plateau side and the pastures and meadow in the mountain unit (Figure 1).

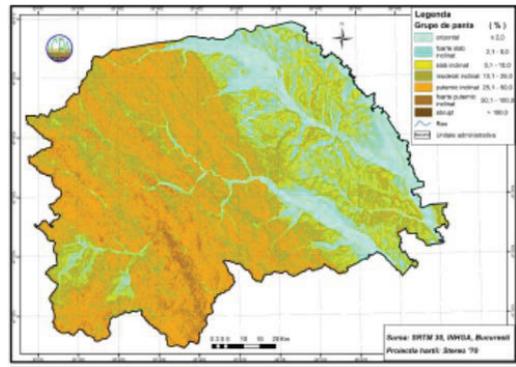
Figure 2. Sloping map in Suceava County

Out of 11,000 ha deforested land, 5,318 ha were converted into agricultural surface, the land use categories recording the most significant increase are pastures and meadows. More than half of the agricultural area is located on land with a slope of more than 5% (Figure 2).

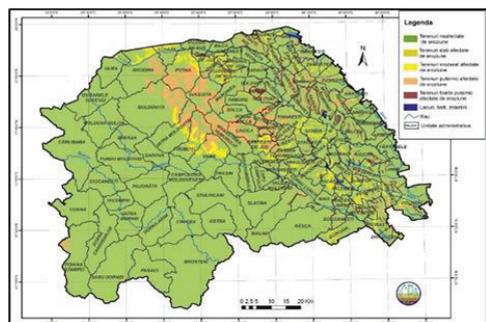
Figure 3. Soil erosion map in Suceava County

Regarding the areas heavily affected by erosion, as seen in Figure 3, predominant in the Suceava Plateau, especially at the contact between different relief forms, is preponderant an agricultural area.

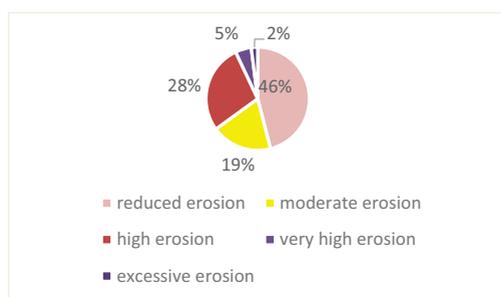
Figure 4. Percentage distribution of agricultural land degraded by sheet erosion

Approximately 31,000 ha of agricultural land is affected by sheet erosion, from low to excessive, and on about half of them the erosion process is manifested with high, very high and excessive intensity (Figure 4).

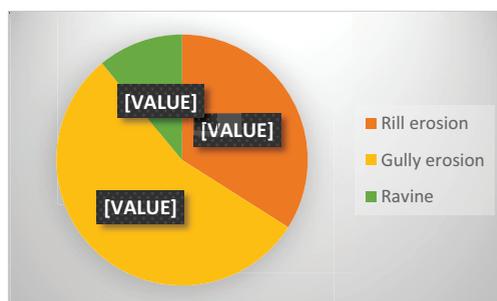
Figure 5. Percentage distribution of agricultural surface degraded by gully erosion

From the analysis of the areas affected by gully erosion, it can be observed a large area occupied gully erosion (Figure 5) due to lack of works and measures to stop them from evolving.

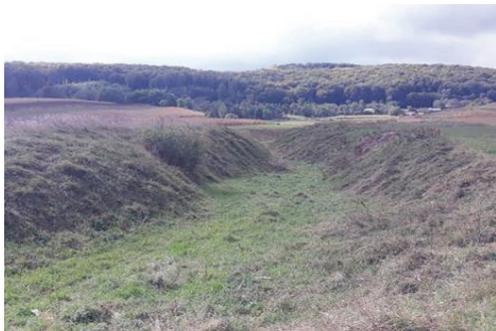
Figure 7. A stabilized gully erosion on arable land in Forăști

Also, the most affected land use categories are arable lands (Figures 6 and 7), followed by pastures (Figure 8), orchards (Figure 9) and meadows.

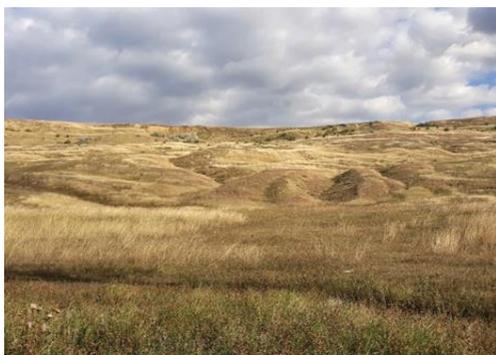
Figure 8. Pasture affected by sheet erosion and gully erosion, Preuțești

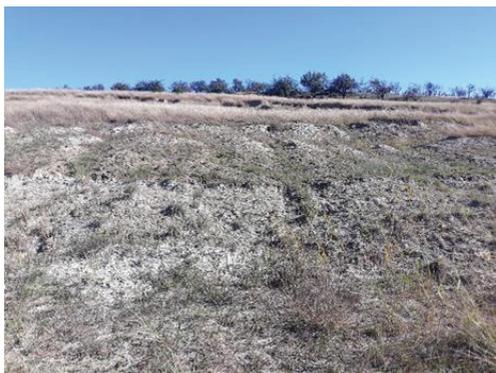
Figure 9. Terraced surface of a degraded orchard affected by sheet erosion, Fălcițeni
