RESEARCH ON SOIL AND CROP MACROELEMENTS CONTENT CORELATED WITH LAND RECLAMATION WORKS

Alexandru SÎNTU-LĂSAT

University of Agronomic Sciences and Veterinary Medicine of Bucharest, 59 Marasti Blvd,
District 1, Bucharest, Romania

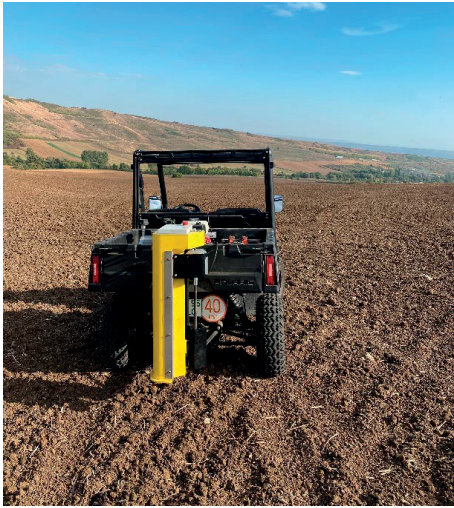
Figure 3. Soil Sampling Equipment

Equipments that formed the basis for collecting field samples (Figures 3-6). In Figure 1, the equipment for probing consists of a Polaris UTV and a Wintex 1000 Soil Probe. In the second figure, as can be seen on the drone remote control screen, the drone is performing a soil scanning mission. Both images, were presented in the Mesentea land.

- Soil sampling system consisting of a Polaris Ranger Electric UTV equipped with a Wintex

1000 electro-hydraulic probe capable of sampling up to 30 centimeters deep.

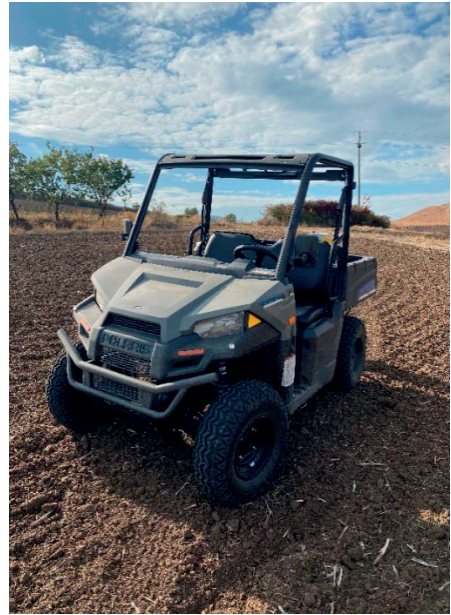
Figure 5. Front of the UTV

In Figure 5, the probing equipment is pictured frontally, and in Figure 6, we can observe the mobile D-RTK station, as well as how a UAV operator must monitor every movement of the drone both on the remote control display and physically where it is positioned. Similar to the previous images, we are still on the Mesentea land.

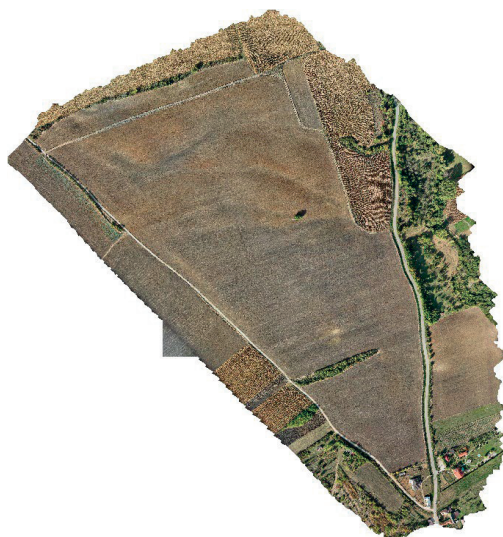
Figure 10. Orthophoto plan Mesentea Field processed with DJI Terra

In this case, we were unable to calculate the NDVI index as the crop had been harvested at the time of index analysis. In comparison to the Ciugud plot, the slope of the terrain in this case is around 7.4%, presenting several aspects in terms of soil movement. As observed, being situated in a coastal area under the influence of torrential rains, there is a quite pronounced erosion, noticeable in Figure 10. Additionally, the land is tilled from the top to the bottom instead of along contour lines, which exacerbates surface erosion. Table 4 precisely depicts what is observed from the drone, namely, soil erosion affecting macroelements. Soil samples were collected starting from the top of the field and continuing towards its base.

It can be observed, especially through the migration of phosphorus and potassium, how evident soil erosion is, as significant quantities have reached the base of the field. Nitrogen, like in the other plot, has been largely lost through leaching and nitrification.
