## STUDY ON LAND AFFECTED BY EROSION IN GORJ COUNTY

Mihaela BĂLAN<sup>1</sup>, Oana Alina NIȚU<sup>2</sup>

<sup>1</sup>University of Craiova, Faculty of Agronomy, 19 Libertatii Street, Craiova, Dolj, Romania

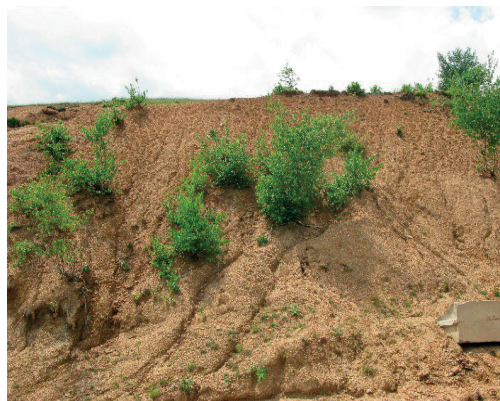
Figure 2. Surface erosion - Trickles in Novaci-Rinca area, Gorj County

Surface erosion occurs under the destructive action of raindrops and/or dispersed runoff, lamination or in the form of small trickles or streams (Figure 2).

The water droplets and the dispersed runoff in the form of a uniform layer of water, acting on the surface of the slopes on which the precipitation falls, produce a fairly uniform erosion of the soil, which becomes evident even for non-specialists when reaching the lower horizons of the soil observable due to different colours from the upper horizon.

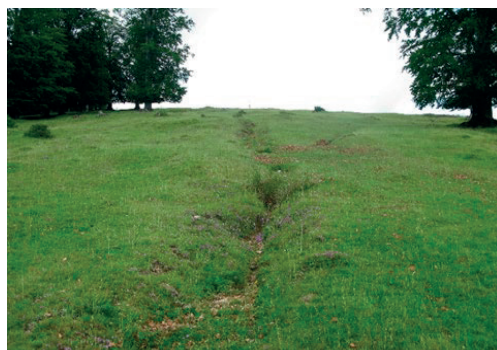
Figure 3. Depth erosion – Rill in the Novaci - Rînca area, Gorj county

Depth erosion causes great damage to agriculture through its formations, rills (Figure 3), gullies (Figure 4) and ravines (Figure 5), which can remove large areas of land from the agricultural circuit, prevent the mechanized execution of works, can affect industrial objectives, human settlements, communication routes, etc.

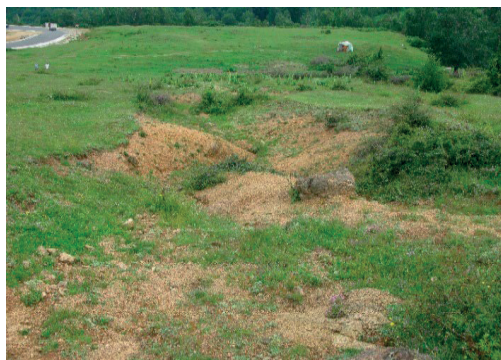
Figure 4. Depth erosion – Gully in the Novaci - Rîncea area, Gorj county

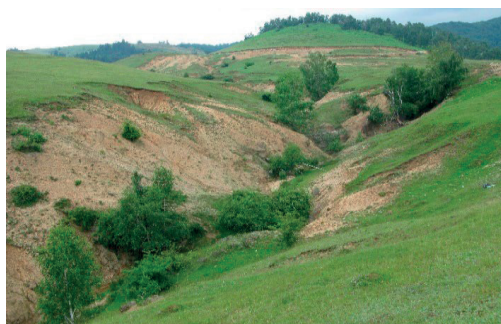
Figure 5. Depth erosion – Ravine in the Novaci - Rîncea area, Gorj county
